## MECHANICAL DEBURRING OF DRILLING-INDUCED EXIT BURRS IN CARBON FIBRE REINFORCED POLYMER COMPOSITES

ANDRÁS GÖDRI<sup>1</sup>, ANNA NIKOLETTA HELLE<sup>1</sup>, AND NORBERT GEIER<sup>\*1</sup>

<sup>1</sup>Department of Manufacturing Science and Engineering, Budapest University of Technology and Economics, Műegyetem rkp. 3, Budapest, 1111, HUNGARY

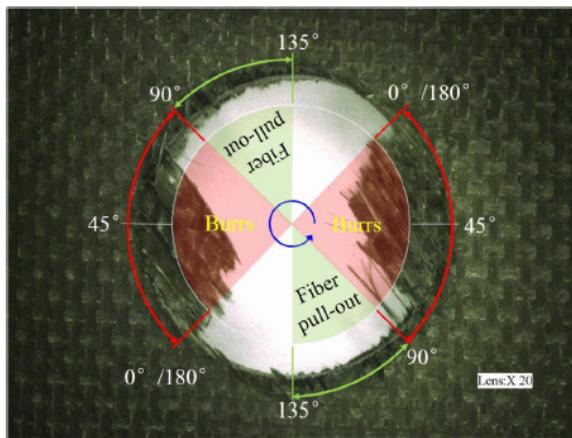
Figure 1: Surface damage as a result of drilling CFRP laminates using a worn tool [?]

Fuji et al. [?] investigated the effect of the cutting edge radius and fibre cutting angle on surface defects after machining and found that if  $r_\beta$  is relatively small, machining will occur with fracture-dominated fibre cutting. However, should  $r_\beta$  be too large, bending-dominated thread cutting takes place, where there is no guarantee that cutting will be successful. They also studied burr formation during drilling and observed that the area around the hole can be divided into four separate regions, where the boundaries of the regions were chosen based on the fibre cutting angles. These four regions are symmetrical in pairs and the same processes take place in them, as can be seen in Fig. ???. If the fibre cutting angle is within the

range of  $90^\circ < \theta < 180^\circ$ , the material is machined under favourable conditions. This range is not characterized by burr formation but fibre pull-out occurs more frequently (depicted by the green range in the figure). If the fibre cutting angle is within  $0^\circ < \theta < 90^\circ$  (illustrated by the red range in Fig. ??), the tool will machine the material under adverse conditions. Within this interval, if the tool edge radius is large, burrs will always form here.

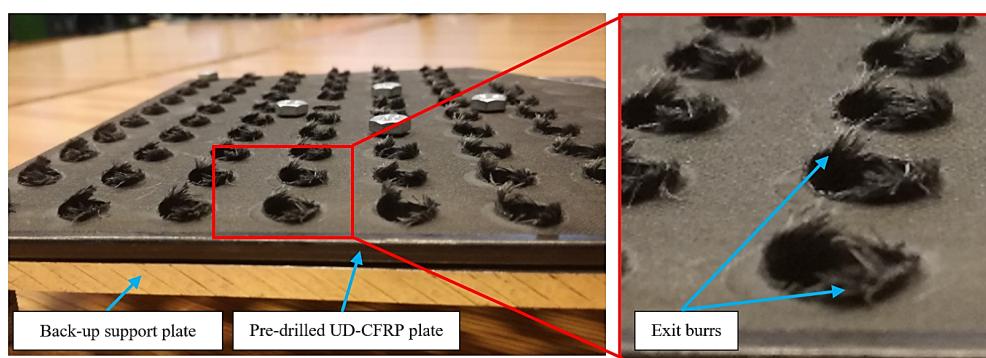
Figure 2: Drilling-induced exit burrs at the edges of the pre-drilled holes in the CFRP composite

The deburring experiments were examined on a pre-drilled vinyl ester-based unidirectional carbon fibre reinforced polymer (UD-CFRP) plate. The main mechanical properties of the UD-CFRP plate at different fibre orientation angles ( $\Phi$ : angle between the fibre direction and load directions of the mechanical tests) are listed in Table ???. The pre-drilled composite can be seen in Fig. ???. The diameter of the pre-drilled holes was  $d = 10$  mm. Given that the performance of the mechanical deburring was tested on the exit burrs, the entrance burrs were removed by a sheet of sandpaper to prevent them from influencing the evaluation.

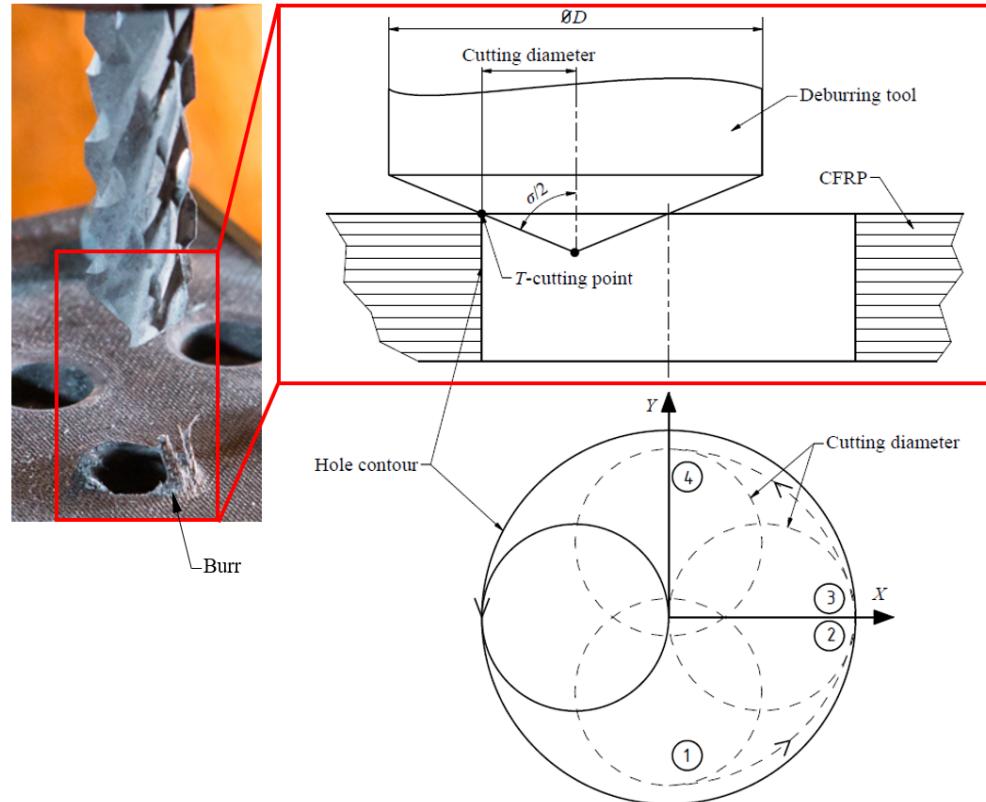
Figure 3: The rolling circular interpolation motion and the  $T$  cutting point of the tool

The deburring experiments were conducted on a Kondia B640 3-axis machining centre. A Nilfisk GB733 industrial vacuum cleaner was used to remove the carbon fibres from the machining zone. A FRAISA 20340.450 uncoated, solid carbide compression end mill with coarse teeth was used with a diameter of  $D = 10$  mm and a point angle of  $\sigma = 135^\circ$ . The schematic diagram of the

deburring cycle is illustrated in Fig. ???. The applied deburring cycle was a rolling circular interpolation motion, where the cutting point of the tool was at the middle of the main cutting edge at the point denoted by  $T$  in the absence of a cooling fluid. The experiments were designed by the full factorial method. The parameter set was chosen based on previous works [?, ?] and suggestions from tool producers. The parameter sets can be seen in Table

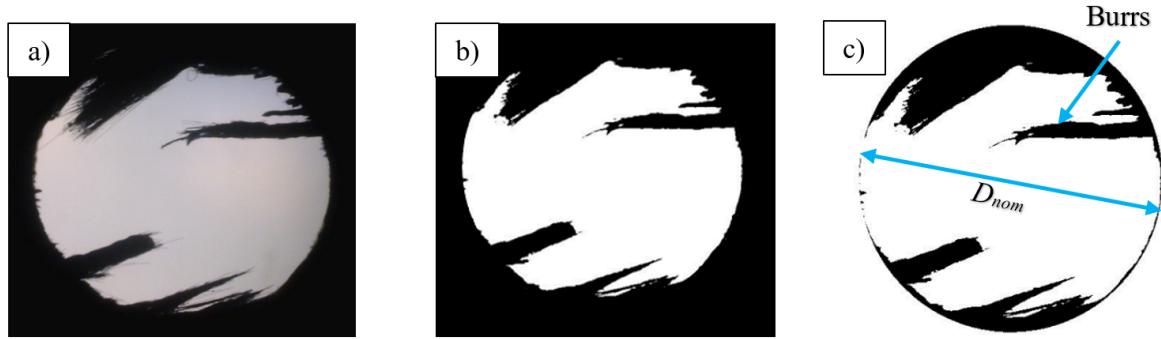
Figure 4: Main steps of the digital image processing method: (a) original image, (b) filtered and segmented image, (c) cut around hole

???. The set values of the parameters are interpreted at the  $T$  position of the cutting tool. Each experimental setting was repeated five times and their order was randomized to eliminate hidden errors during the experiment. A Dino-Lite Premier AD7013MZT digital handheld microscope was applied for image capturing before and after deburring. The drilled and deburred holes were captured by the microscope from the top side while they were illuminated from the bottom side by an LED source to improve the contrast of the images. The digital images taken before and after deburring were processed to determine the burr area ( $A_b$ ). The main steps of the digital image processing are illustrated in Fig. ???. Firstly, the original image was taken, before being filtered and segmented in the second step. Finally, the image was cut to form a particular shape

in order to determine the burred area parameter by pixel counting and transformation. The  $A_{b0}$  parameters, which are listed in Table ??, were determined before the deburring experiments.

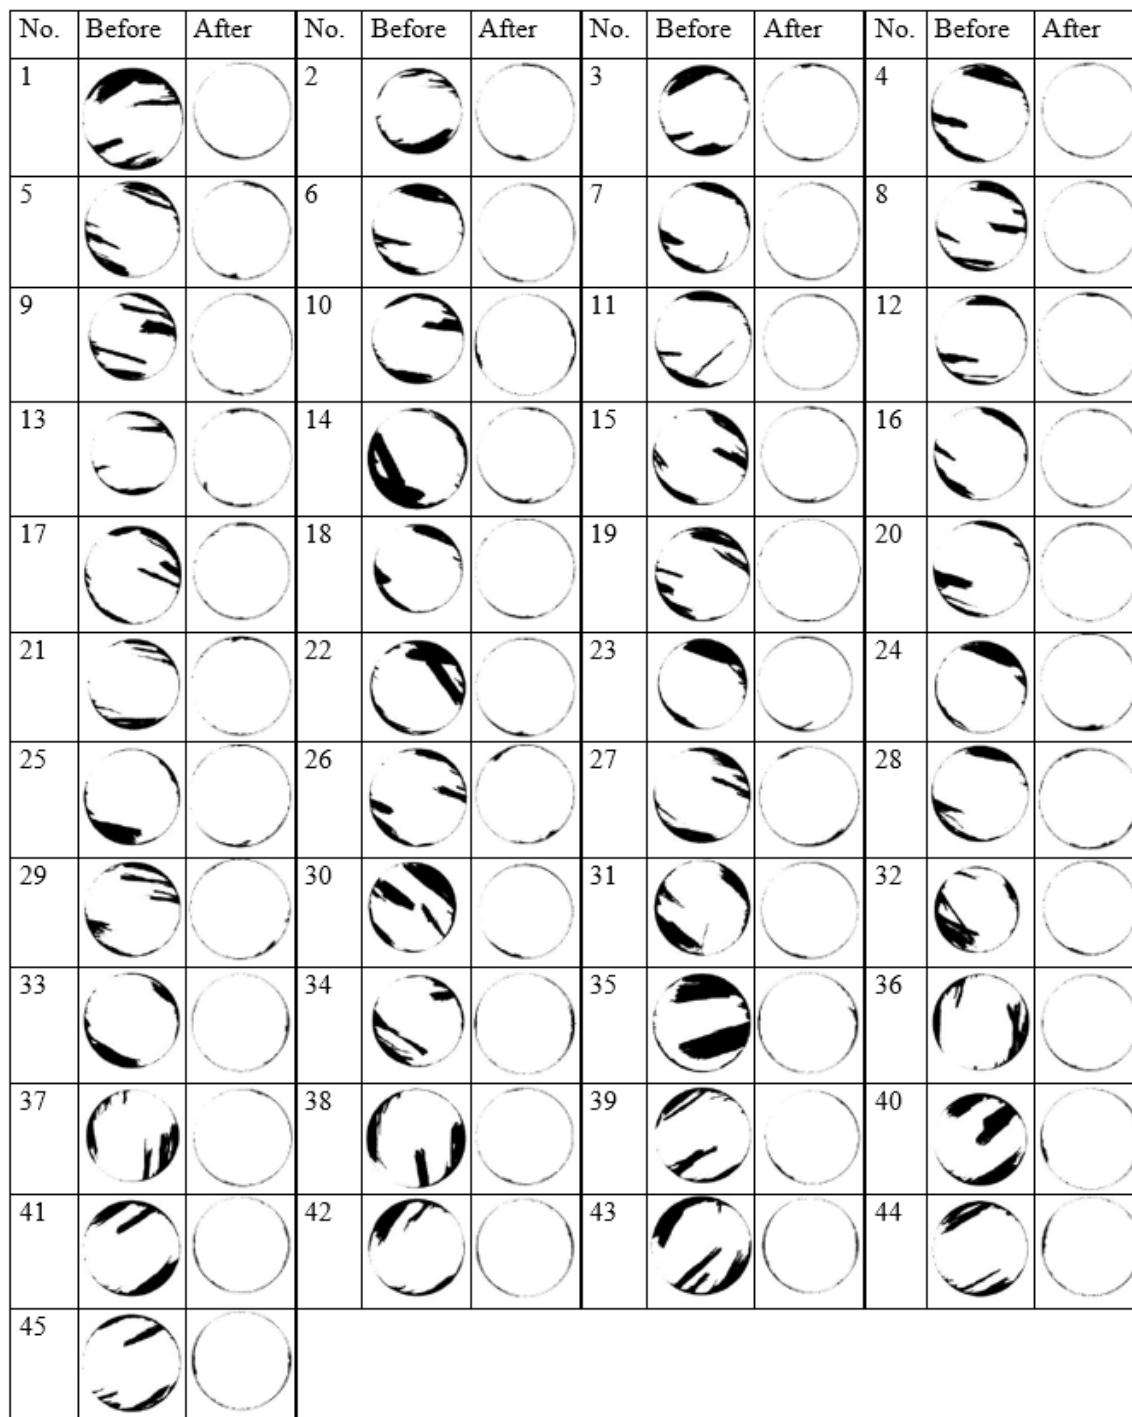
Figure 5: The digital image processed holes – before and after deburring

the filtered and segmented photos.

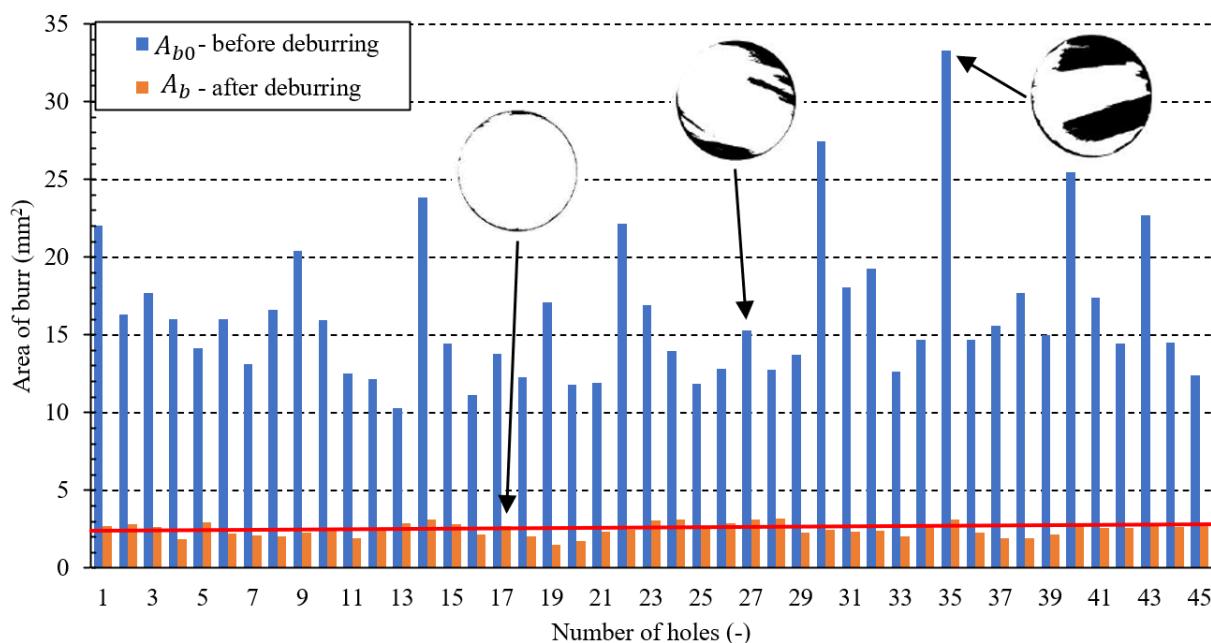
Figure 6: Comparison of burr areas before ( $A_{b0}$ ) and after ( $A_b$ ) the applied deburring cycle 8

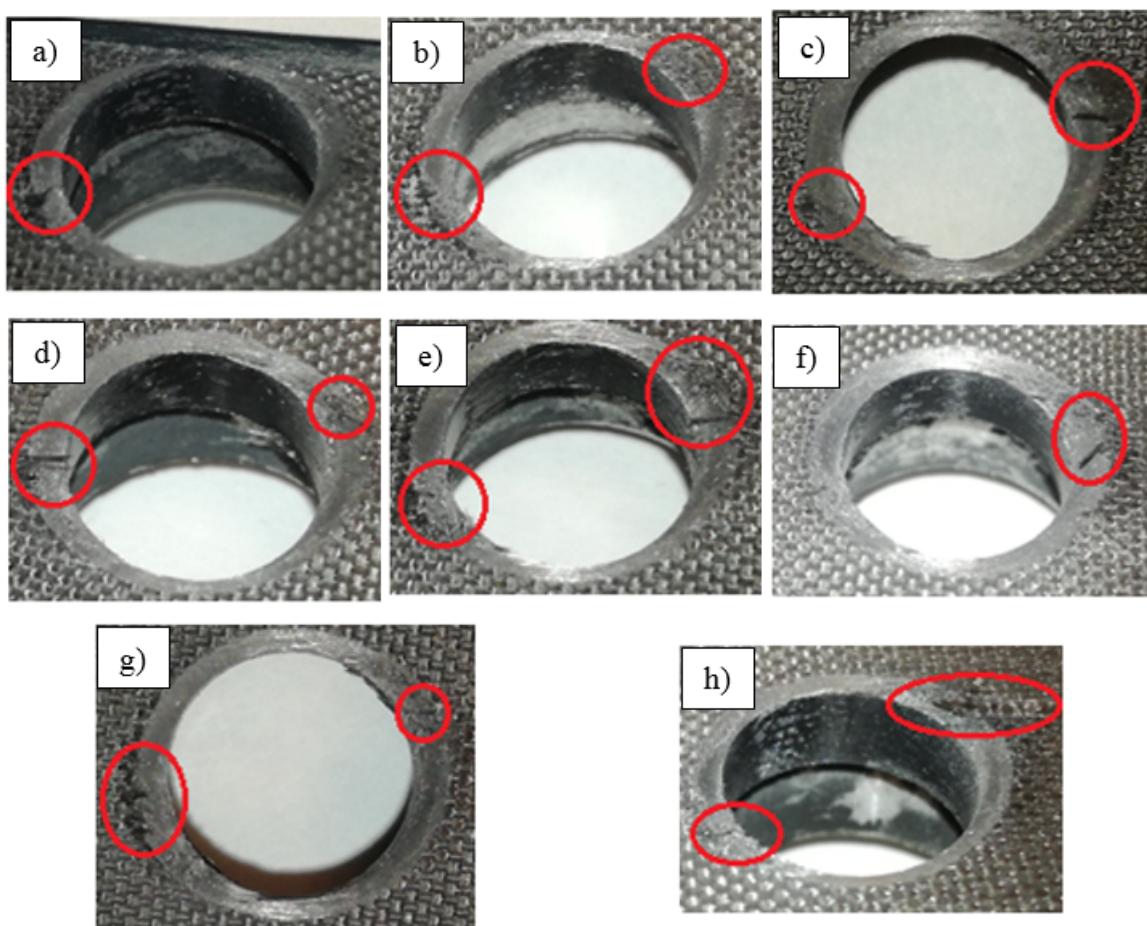
Figure 7: The holes with observed macro-type errors: a) burrs, b) uncut fibres and rough surface roughness, c) burrs and uncut fibres, d) uncut fibres and rough surface roughness, e) rough surface roughness, f) uncut fibres, g) burrs and uncut fibres, h) rough surface roughness and delamination

In addition to the analysis of the burred area, the deburred workpiece was quantitatively evaluated by taking a high-resolution photo of each hole which were then visually evaluated by searching for machining-induced surface defects, e.g., uncut fibres, fragmentation, delamination, burr formation and burnout. These enlarged images of the holes present all the macro-type errors which could be observed and identified (Fig. ??a-h). The properties of the critical holes can be seen in Table ???. It was observed that the macro-type errors were characteristically uncut fibres. It can also be noticed that the defects mostly appeared symmetrically on the chamfers as a result of the directional dependence of the unidirectional CFRP plate, as was also observed by Fuji et al. [?].

favourable. Only 1 out of the 5 repetitions for the parameter set  $v_c = 20 \text{ m/min}$  and  $f = 0.01 \text{ mm/rev}$  consisted of macro-type errors, possibly as a result of a random influential effect. No macro-type errors were visible by the naked eye in the other holes.

- According to the quantitative evaluation, the observed holes with macro-type errors show that the parameters  $v_c = 20$  m/min and  $f = 0.1$  mm/rev can be identified as the most unfavourable setup, followed by the parameter set  $v_c = 60$  m/min and  $f = 0.1$  mm/rev.
